# CASE HISTORY

Application: **Water & Environmental**

Technology: **High Resolution Optical Televiewer (Hi-OPTV) borehole inspection**

Location: **Storrington and Goodworth, England**

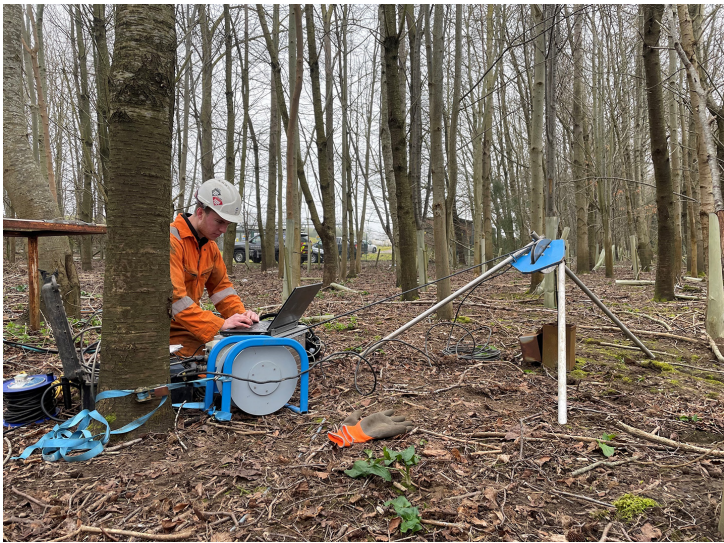
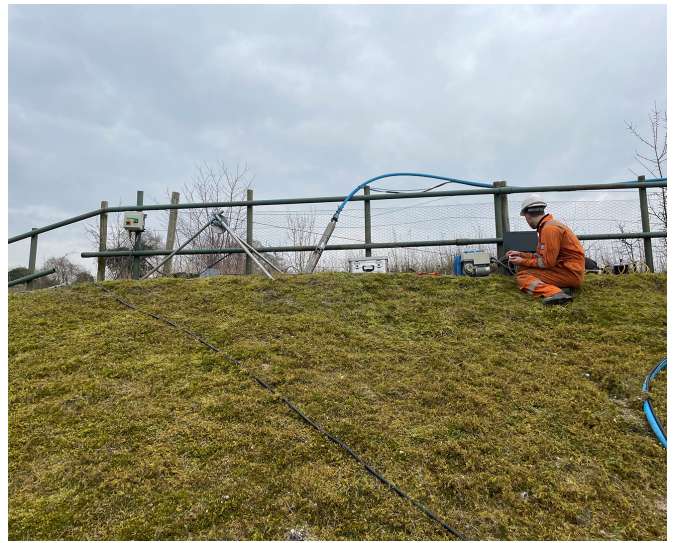
With all the boreholes being inaccessible by vehicle, Robertson Geo deployed their smallest but highly mobile logging unit consisting of the Mini winch, tripod and Micrologger2.

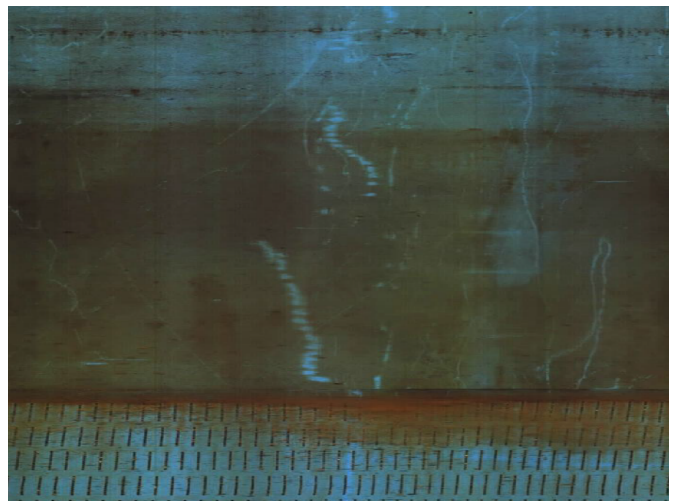
*An example of the recorded data clearly illustrating the slotted PVC lining:*

The High Resolution Optical Televiewer was easily able to display the integrity of the PVC lining and the exact depths at which the lining became slotted. These boreholes were drilled some twenty years ago with the client holding very little knowledge to their current depths, stability and the condition of the PVC prior to the logs conducted by Robertson Geo Services.
